JOHN R.S. EDGAR CONSULTING INC.

### **EIFS**

Exterior Insulation and Finish Systems

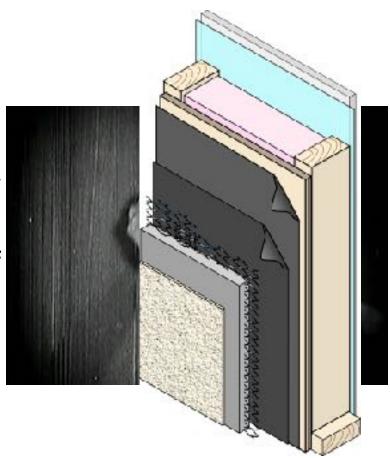
#### What isn't EIFS

- Stucco isn't EIFS
  - stucco is a cement-based plaster ~20 mm thick
  - stucco is supported by lath
  - stucco requires joints every
     13.3 m² at a minimum
  - it may have an EIFS type of finish
  - stucco sounds hard when you knock on it.

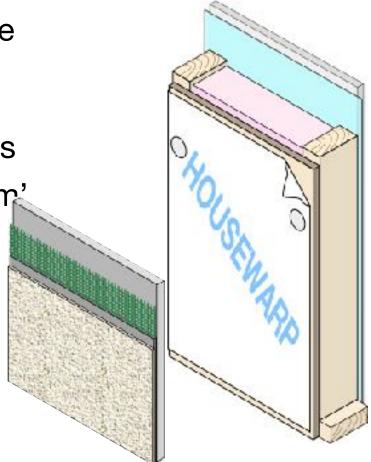
#### What is not EIFS

- Cement board with a base coat, mesh and finish
- Alternative with insulated sheathing and taped joints
- not evaluated as a 'system' and has no performance requirements

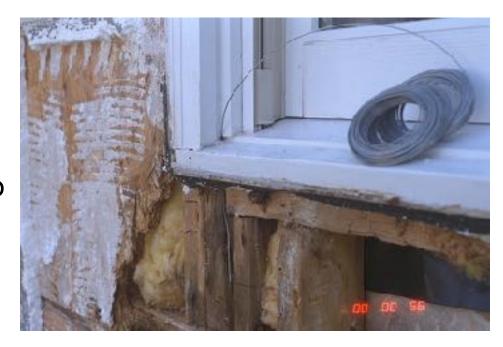
#### Window Problems

- Windows leak
- 50% damage under corners of windows
- Flashing has always been required under windows
- Flashing is required to drain outbound of the wall finish
- Photos from 1996
- Labelled on internet as an "EIFS problem"

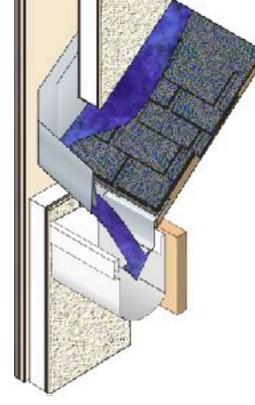
## Diverter Flashings

- Missing diverter flashing resulted in 35% of NC water intrusion issues
- Water flows into the wall
- Diverter directs water into eavestrough.
- If it is missing it should be corrected.

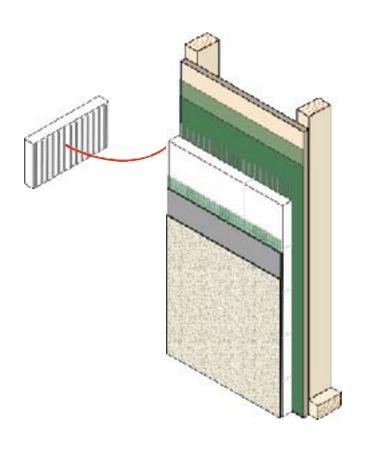
#### Current EIFS

- EIFS changed to include back-up protection and drainage.
- two coats LA-WRB required over wood sheathing.
- Vertical ribbons of adhesive allow incidental water to drain.

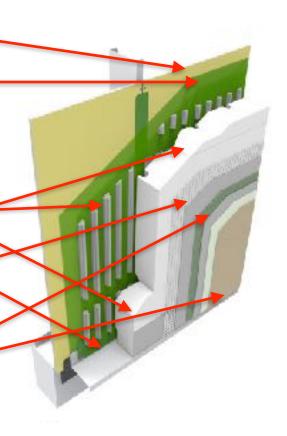
#### What is EIFS?

- Substrate
- Liquid-applied water resistive barrier
- Flashing
- Pre-wrapped starter
- Adhesive ribbons
- GDDC insulation
- High impact mesh
- Standard mesh + base coat (lamina)
- Finish

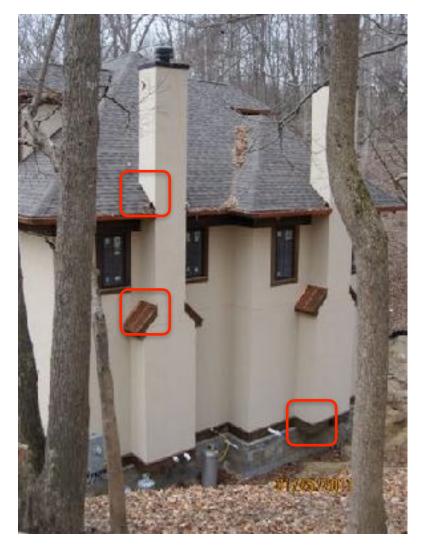
## **EIFS Check**

- Windows let you know if there is a concern.
- Check for signs of wetness with a Tramex Moisture Meter.
- If indications show moisture over 30%, then invasive inspection is recommended.

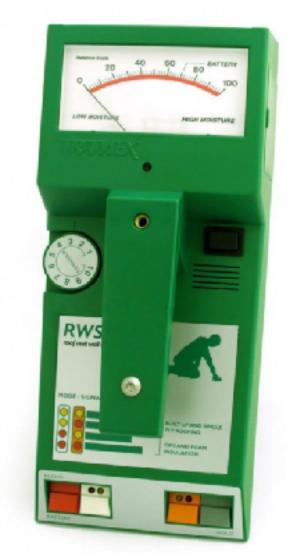
#### Windows - the 50%er

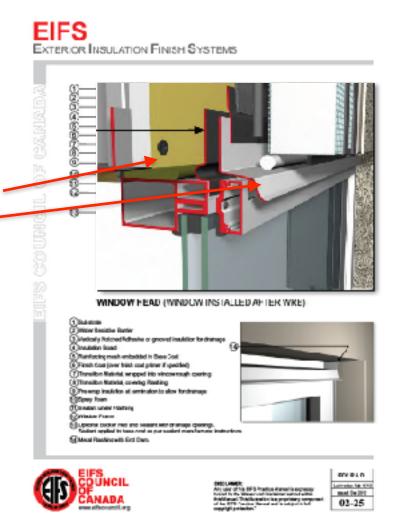
#### Window Head

- Rough opening protected
- Head flashing
- What to look for:
  - flashing
  - end dams
  - drainage space

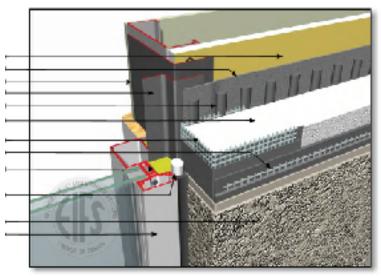
WINDOW JAMB (TRANSITION "WRB" MATERIAL AT ROUGH OPENING AND TRANSITION MEMBRANE ONTO FRAME)

#### Window Jamb

- Rough opening protected
- What to look for:
  - 13mm (1/2") sealant bead
  - Sealed to base coat
  - Is it still bonded?
- A 'fillet' seal between window face and EIFS finish is not correct.

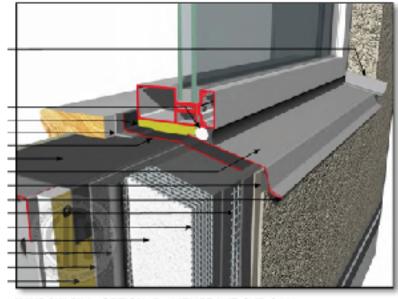
WINDOW SILL, OPTION -B- (MEMBRANE SUB-SILL)

#### Window Sill

- Sill flashing to drain outbound of cladding
- Code requirement for all windows and all cladding
- Will have to change for SB12 and new energy codes

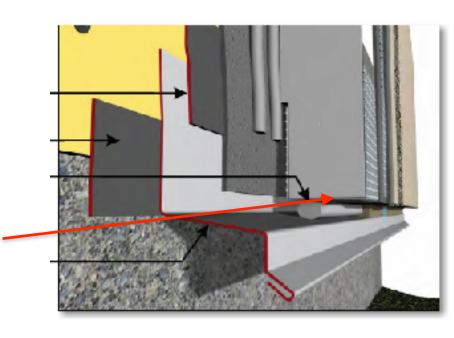
## Termination above grade

- Above grade!
- Flashed to drain
- Sealed with drains and bug vent screens
- Pre-wrapped or backwrapped

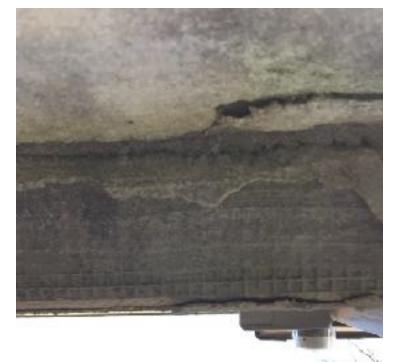
#### Selfie Cameras

- Good for checking the underside of termination
- Example = a project from 1980's
- Has some wear and tear but was properly done for the time.
- Will require maintenance

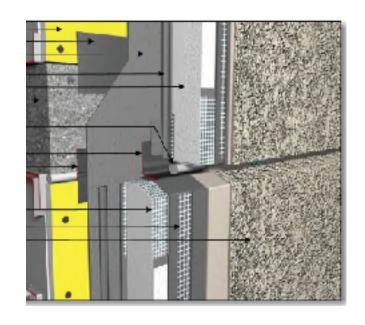
#### Floor Line Joints

- A requirement for wood frame always!
- If it is not there, then cross grain shrinkage in joists may crush the EIFS.
- If it hasn't been there for many years and nothing has happened ... it won't happen.

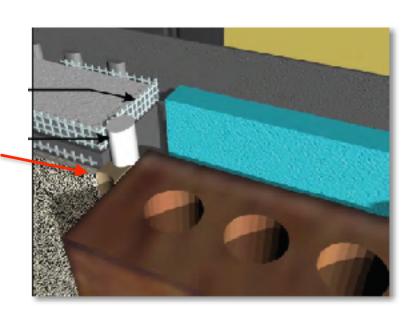
# Vertical Termination at Another Material

- 20 mm (3/4") sealant joint
- Sealant bonded to base coat, not finish

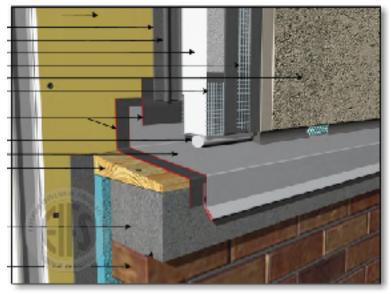
TERMINATION ABOVE DISSIMILAR CLADDING

# Horizontal Termination at Another Material

- Water draining behind EIFS flashed to exterior
- What to look for:
  - flashing drains beyond cladding below
  - Sealant with gaps or no sealant (not required)
  - If no sealant, check for back-wrap

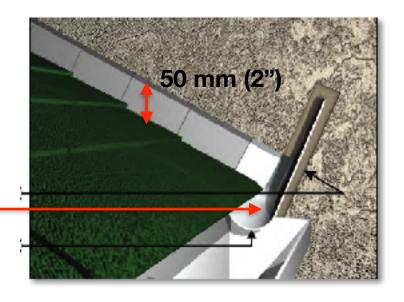
#### Termination at Roof

- Clearance of 50 mm (2") required
- Allows re-roofing and debris clearance
- Another view of a commercially available diverter flashing

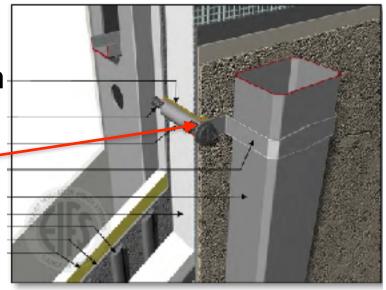
RAIN WATER LEADER ATTACHMENT

#### Attachments

- The detail that follows completion of EIFS
- Should be fastened through sealant-filled PVC sleeve
- Look for sealant bulge behind flange
- Rarely done, but evidence of a really good job if present.

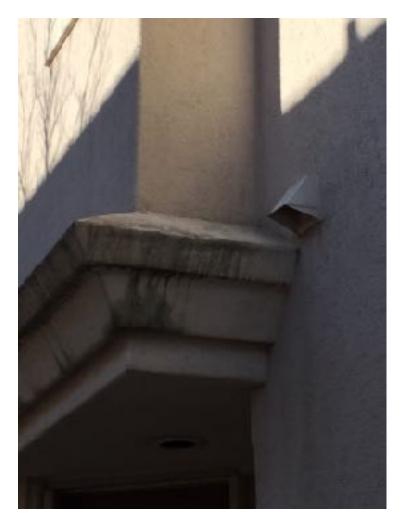
#### Older Installations

- Dirty, exposed surface deteriorating
- Can be cleaned with low pressure spray wash (500 PSI max)
- Judgement call:
  - re-coat with waterproof base coat

tear off and properly flash

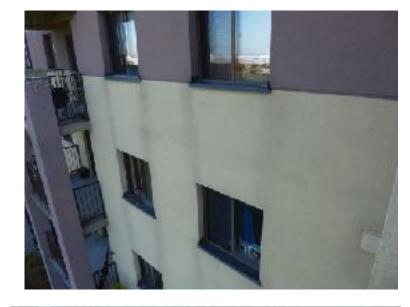
#### Maintenance

- 25-year-old EIFS
- Needs cleaning
- Minor surface cracks
- Mechanical fastener ghosting
- Recommend new application of base coat, mesh and finish.

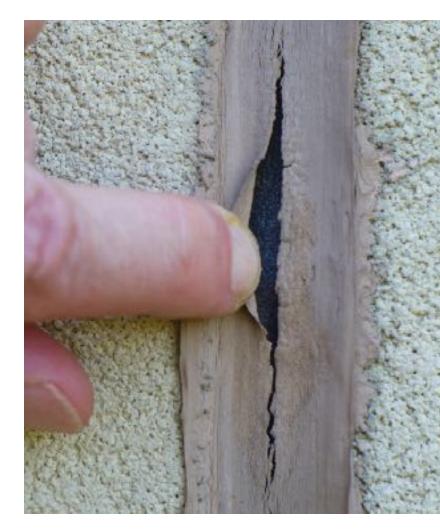
## Sealant

- Requires replacement
- This was too thin failed cohesively
- Cut out and replace or patch over.
